Hydro-Balanced Stuffing Box Field Test

Field Test Project Report

Date Published: May 28, 1999

Rocky Mountain Oilfield Testing Center

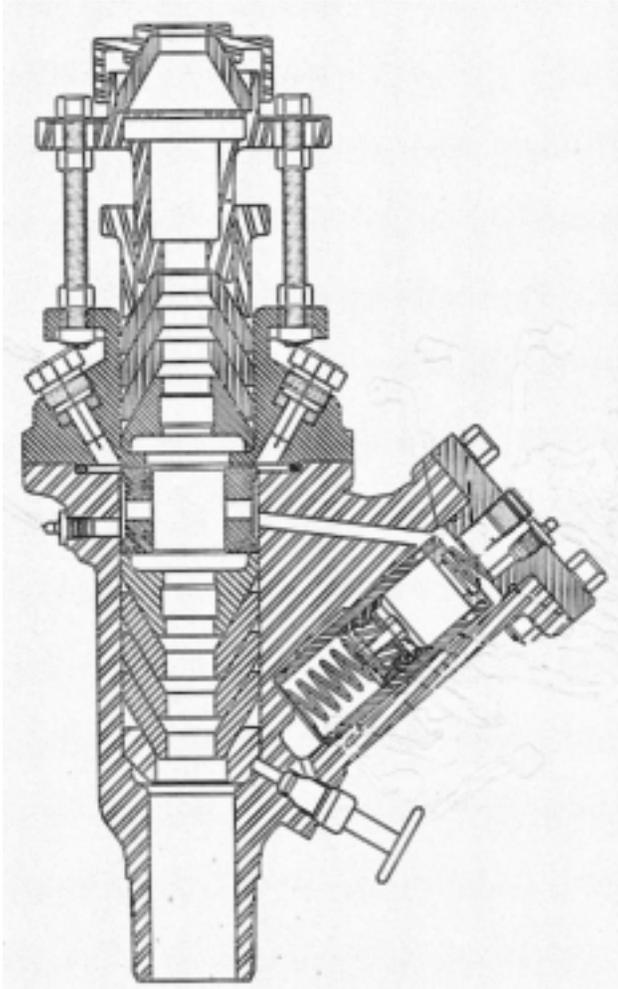
A drawing of the grease version is shown in Figure 1. The grease version can be pressured with a grease gun to maintain the positive pressure in the inner chamber.

Figure 1 Hydro-Balanced Stuffing Box, Grease Version

It does not require pressure support from the casing to energize the grease reservoir. As long as the primary seal is not leaking, the grease version functions the same as the oil version. However, after an extended period, the packing seals will begin to leak, and the grease will begin to leak out. As it does, the piston assembly will move up and eventually reach the end of its travel and stop. If the leak is not noticed, and the grease supply replenished, well fluids will eventually begin to leak past the secondary and primary seals. The grease version will require more frequent charging with a grease gun, while the fluid version would refill automatically from the fluid reservoir. In either case, if there were a leakage to the atmosphere, the cleanup costs would be greatly reduced if not eliminated.

The design for the level indicator is a thin solid bar approximately 1/8" in diameter and 8" long. It should be threaded at one end and fitted with a nut. It can be placed inside a standard 1/4" NPT tubing fitting less the ferrule. Small o-rings can be placed around the bar inside the fitting and screwed down to create the seal. The nut will prevent the bar from exiting the tubing. The male end of the fitting can be screwed into the grease cap where the pressure gauge is located. The bar can be inserted until it touches the piston prior to operation. Some adjustment is needed to keep the bleeder valve, gauge, and

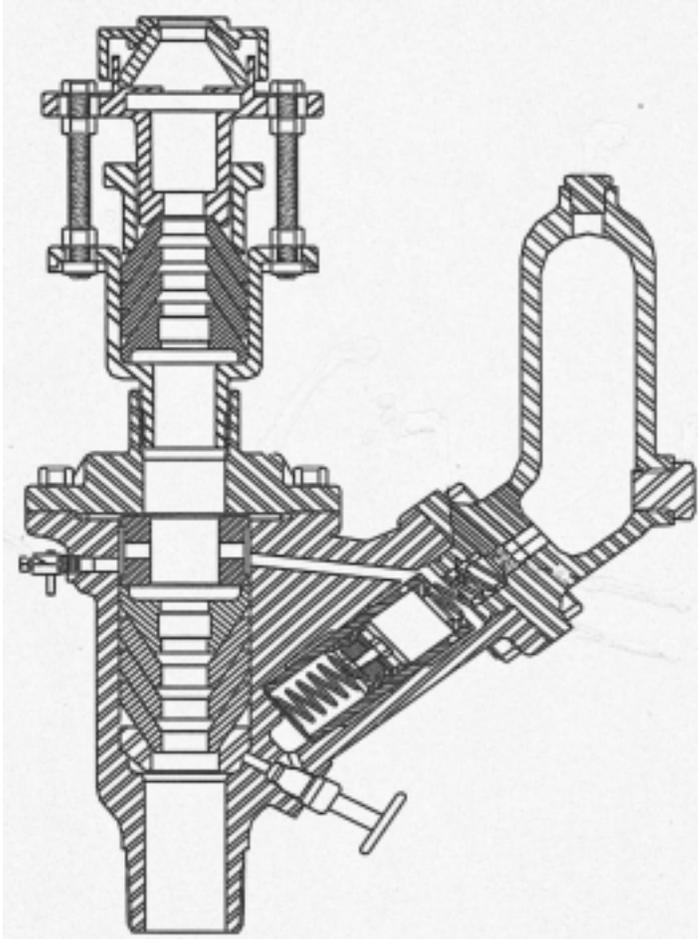
The oil version is an automatic feed system. A drawing of the stuffing box is presented in Figure 2. The design of the oil version is such that the casing

Figure 2 Hydro-Balanced Stuffing Box, Oil Version

pressure is used to maintain a constant positive pressure on fluid reservoir, and ensure that the inner chamber is constantly replenished with fluid from the reservoir. If this is not possible, an artificial pressure source must be used to pressure the fluid reservoir. Due to its automatic feed system, it can be left unattended for a longer period of time than the grease version. An automatic low-level shut off switch can be used to automatically shut down the pumping unit if the reservoir containing the safe fluid runs dry.

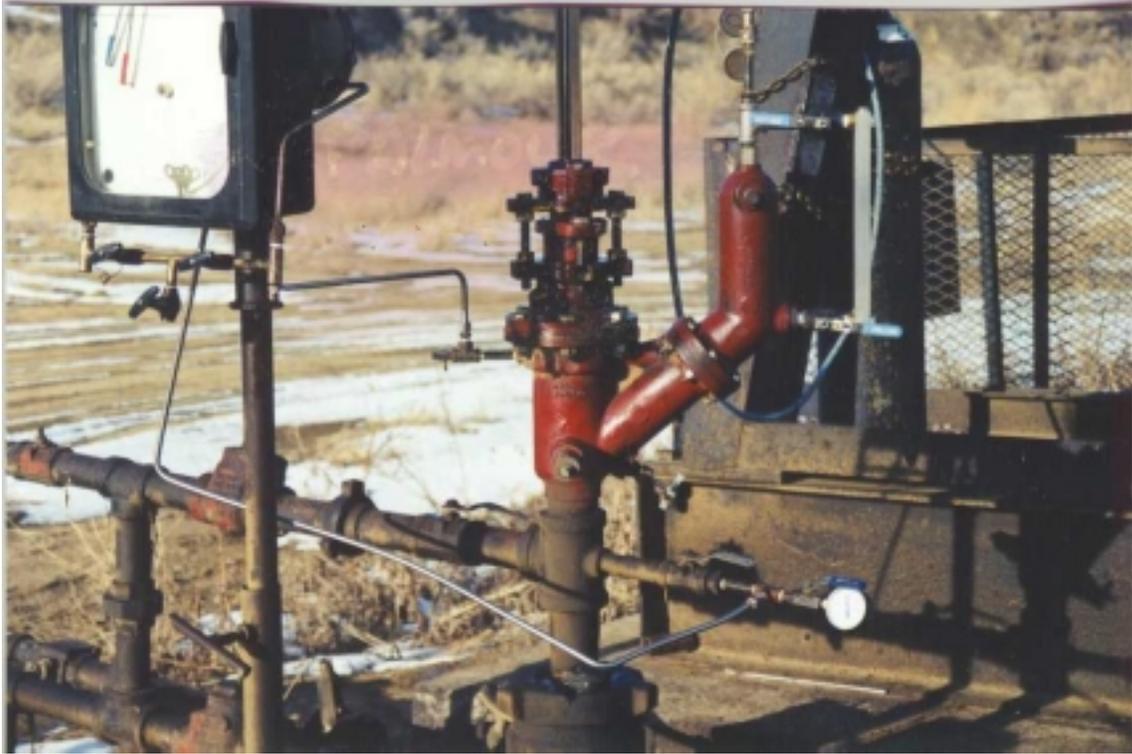
Figure 3 12AX11 Fluid Version Installation

The oil level in the reservoir can be monitored with a sight glass. Figure 3 shows the sight glass installation.

The completed installation of the oil version can be seen in Figure 3.

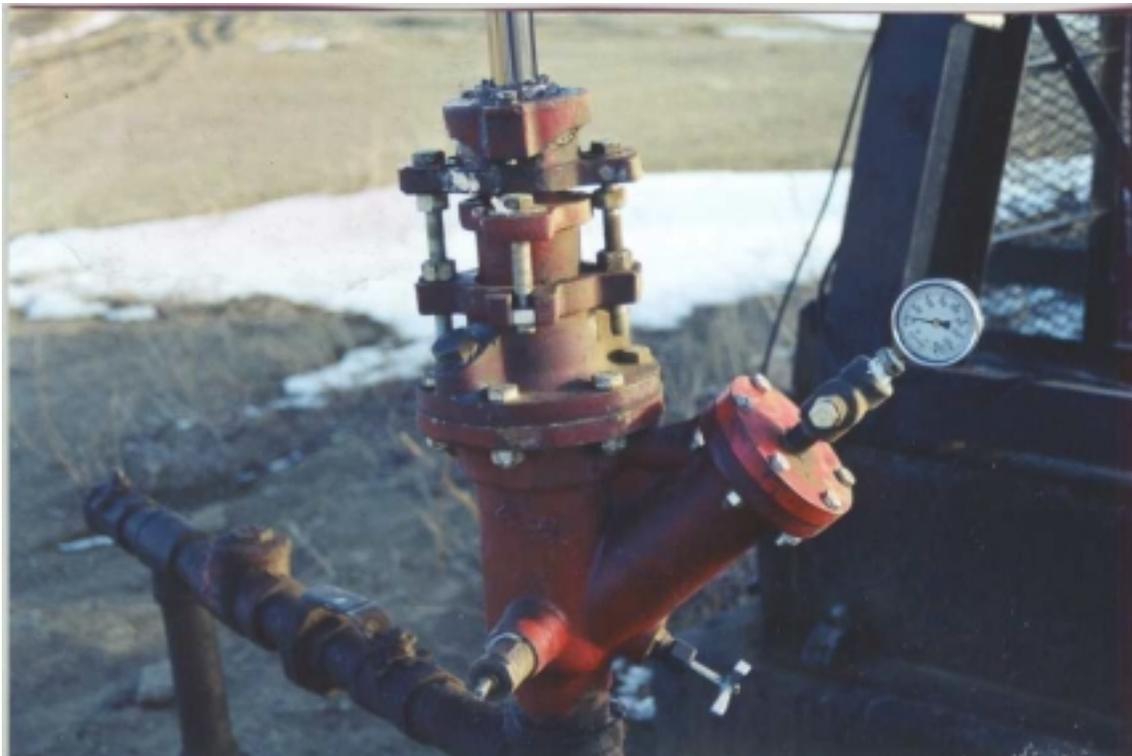
Figure 4 62A3 Grease Version Installation

The grease level indicator that was supplied was not installed since there was a danger of the internal pressure ejecting the indicator out of the housing and presenting a safety hazard. The installation of a nut on the bottom of the bar was recommended to prevent the possible problem. The grease was filled to the same pressure each time using the pressure gauge. The completed installation can be seen in Figure 4.

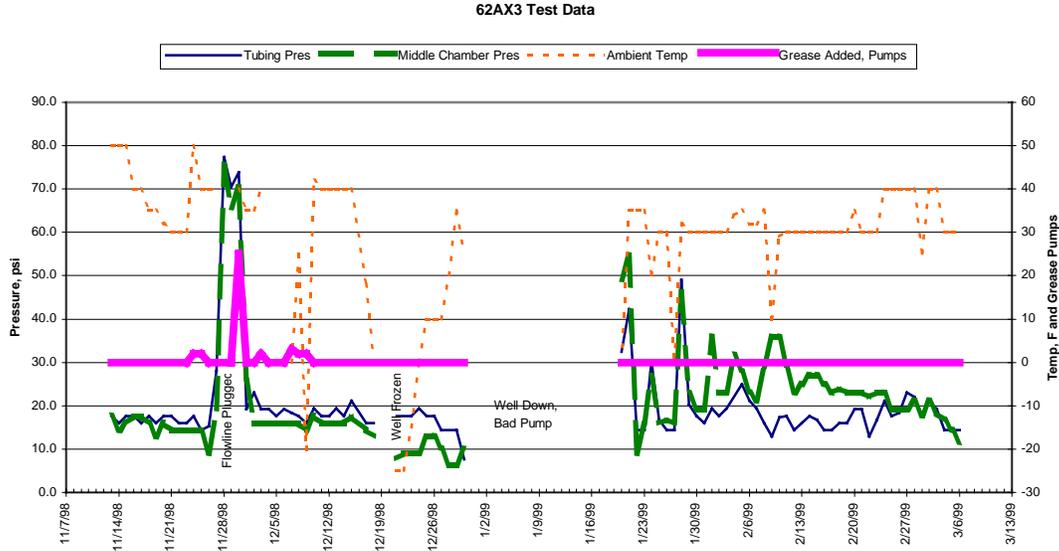
Figure 5 Well 62AX3 (Grease Version) Test Results

It can be seen from Figure 5 that the middle chamber pressure tracks the changes seen in the tubing pressure. On November 28, 1998, the flowline plugged up with paraffin and caused the tubing pressure to rise drastically from 16 psi to approximately 73 psi. The middle chamber pressure likewise rose. However, during the event, a half tube of grease was used. About three pumps of grease were noted on top of the stuffing box. This amount of leakage was considered small compared to what would have been expected from a conventional stuffing box. It was the only leakage observed from the top of the stuffing box during the term of the test. It is not clear why the majority of the grease leaked into the tubing when the tubing pressure was so high.

On December 18, 1998, extremely cold weather caused the well to freeze up. Although production was down for several days, there was no effect on the stuffing box. A lower-temperature grease was obtained to prevent solidification in the middle chamber. As long as the well was pumping, polished rod temperature held constant at 50 degrees F. When the well thawed out and started pumping again on December 21, it was discovered that the pump was bad. The well was

When the well was returned to production, the middle chamber pressure was maintained above the tubing pressure. This is thought to be a function of the tightness of the primary packing. There was no further grease usage, and no further leakage observed on the top of the stuffing box. Data was collected until March 6, 1999.

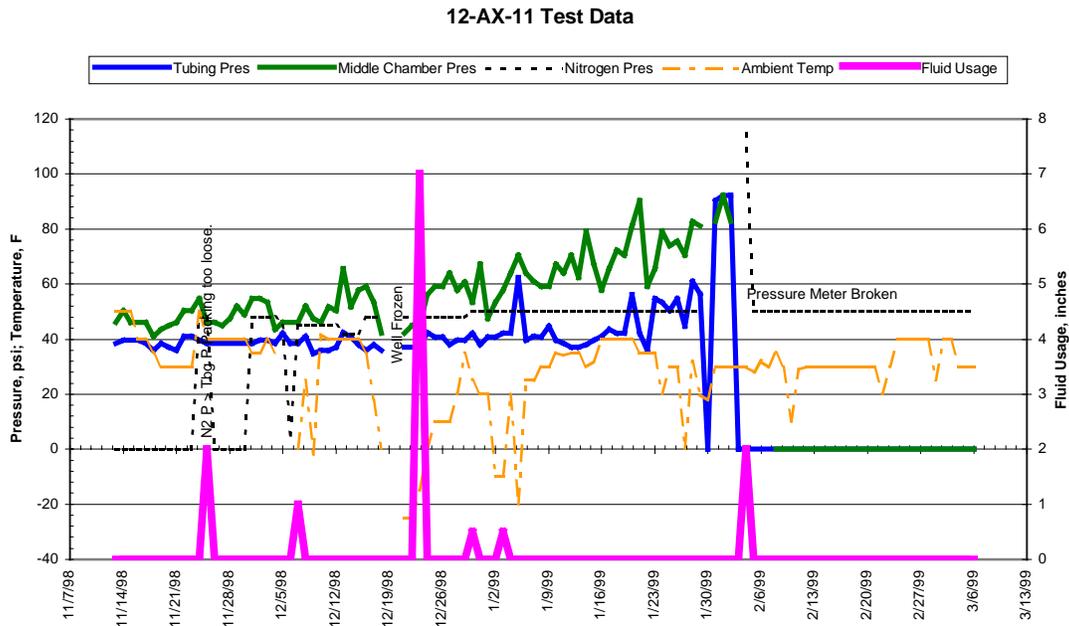
When 12AX11 started operation with the Hydro-Balanced Stuffing Box, a nitrogen source was required to maintain the middle chamber pressure above the tubing pressure. On November 24, 1998 when the nitrogen pressure was initially applied, the fluid in the middle chamber was quickly forced into the tubing. Within 4 or 5 pump strokes, the entire fluid reservoir was used up. The pressure on the nitrogen bottle regulator was decreased to 5 – 15 psi above the tubing pressure. Fluid leakage was decreased to 2 inches in a 24 hour period. Nitrogen pressure was removed during the Thanksgiving holiday weekend to prevent any potential damage to equipment. Nitrogen was reapplied on December 2, 1998. This time the regulator pressure was reduced to 45 psi. An inch of fluid was used overnight. On December 10, the nitrogen pressure was reduced to 42 psi. Tubing pressure was ranging from 36 to 41 psi. The safe fluid level seemed to stabilize. Test results are shown in Figure 6.

Figure 6 Well 12AX11 (Oil Version) Test Results

On December 15, 1998, the primary packing was tightened and the nitrogen pressure again raised to 48 psi. Performance was good until December 19, when the weather turned extremely cold. The well froze up. When it was restarted on December 23, there was considerable loss of fluid both on top of the stuffing box and into the well fluids until the polished rod warmed up to its normal operating temperature of 50 degrees F. The upper and lower packing elements were tightened up. By the time the stuffing boxes were tightened, there was seven inches of fluid lost. The well operated for 8 hours before freezing up again. The next morning, the well was restarted without incident. There was no further fluid leakage.

In early February, the flowline began to experience plugging from paraffin. Tubing pressures spiked near 100 psi, while the middle chamber pressure reached 170 psi. This was in excess of the limit of the Barton pressure recorder, and the meter was damaged. Associated with this event was the usage of 2" of fluid. There was evidence that the majority of the leaked fluid was through the primary packing. The flowline was treated with hot water to remove the paraffin plugs. The safe fluid reservoir was refilled, and the nitrogen pressure was reset at 50 psi. The stuffing box continued to operate until March 6, 1999 with no further fluid usage or leakage.
