PERGAM GAS LEAK DETECTION

Final Report for the Period of August 2006 to January 2007

Lyle Johnson, RMOTC, Casper, WY

Rocky Mountain Oilfield Testing Center (RMOTC)
Work performed under CRADA 2006-074

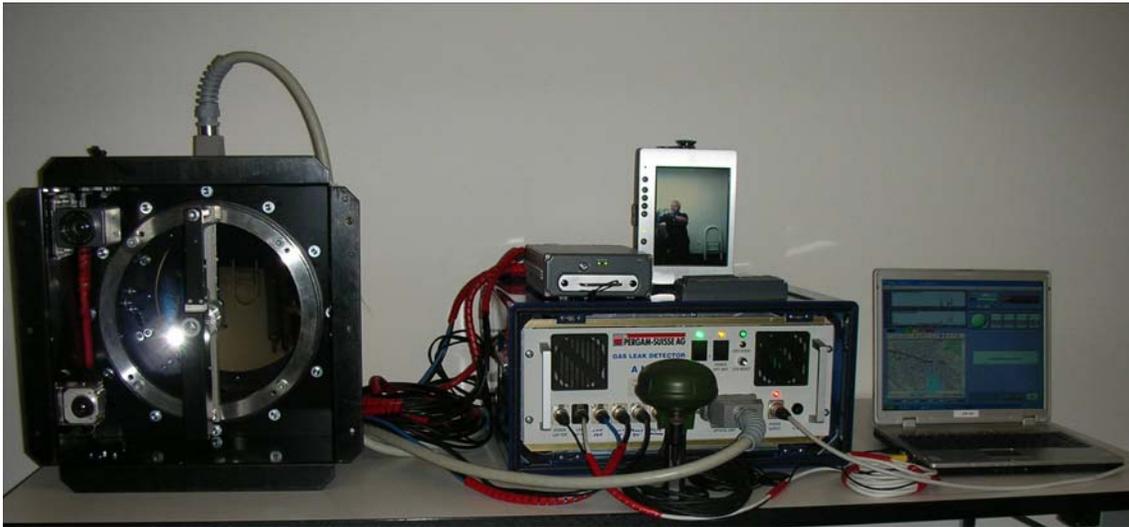
Figure 3. ALMA system optical unit (left); electronic unit, digital video recorder, and pilot monitor (center); and notebook computer (right)

The Pergam-Suisse ALMA system (Figure 3) detects methane gas leaks from airborne platforms (predominately helicopters, Figures 4 and 5) by passing a laser beam through the methane cloud that surrounds the leak source. The infrared laser light emitted includes a wavelength in the region of 1,650 nm that methane absorbs. The system analyzes the laser light backscatter to determine how much, if any, of the laser energy

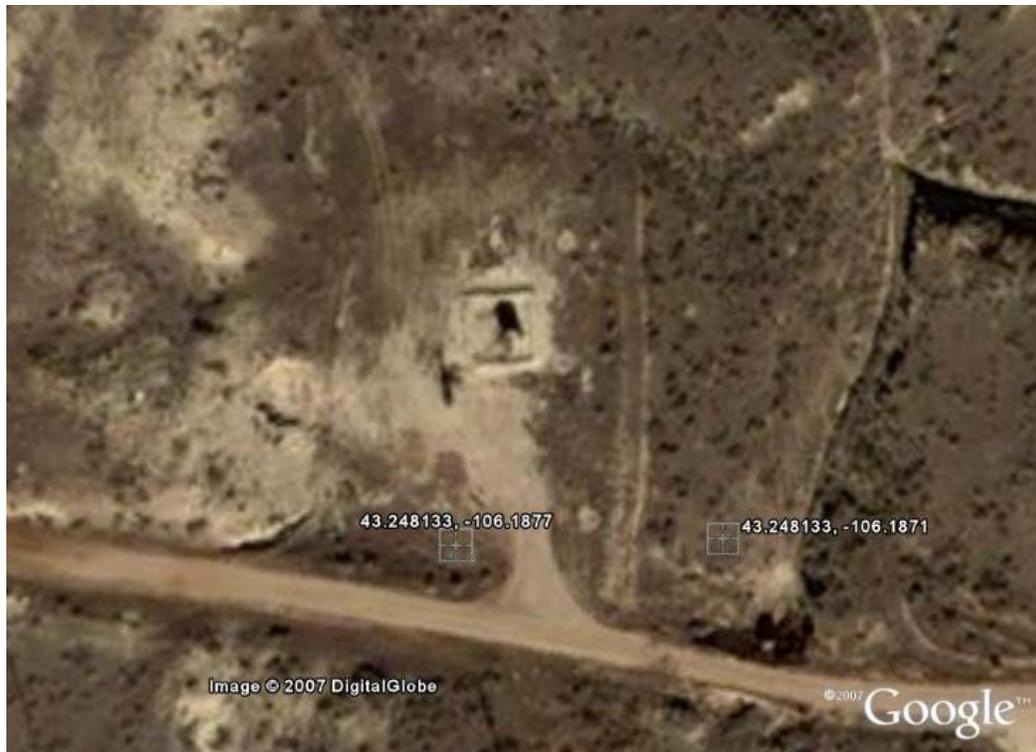
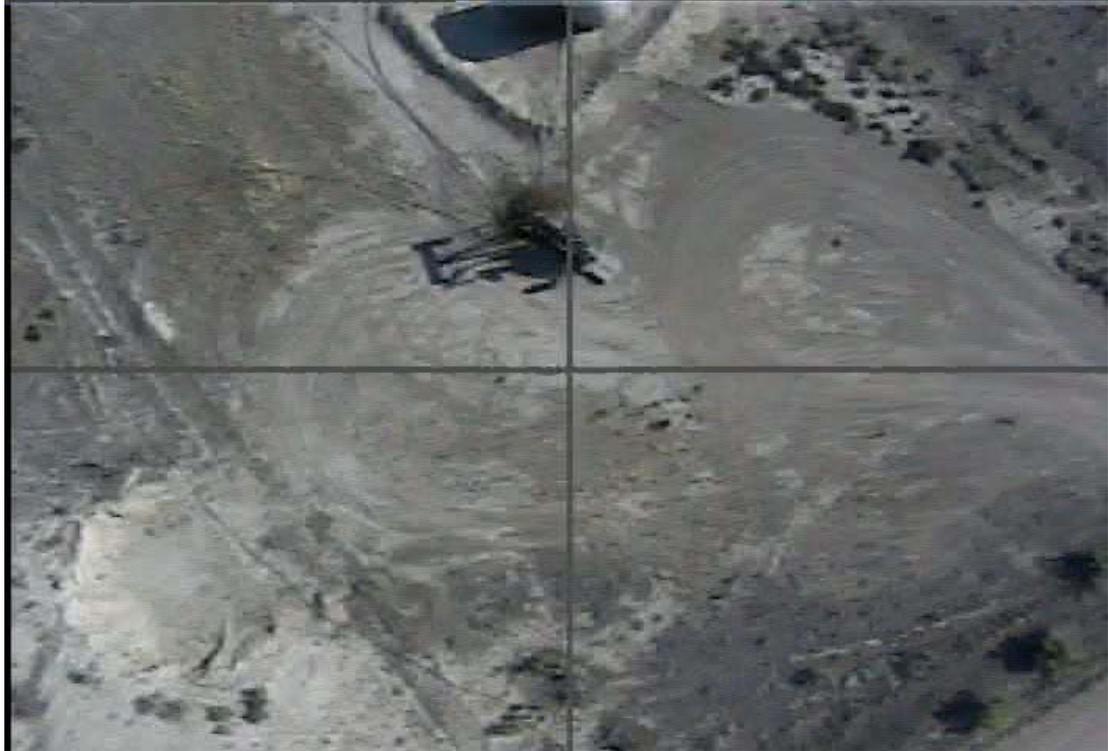
The cause of the misses was an unanticipated difference in wind direction at Leak Source 1 compared to ground and airborne indications. The wind was very strong with an average speed of 17 mph (28 kph) and gusts up to 25 mph (40 kph). It is known that Leak Source 1 was south of the rig on the west side of the road, but Figure A13 shows the coordinates on the right side of the road. The true position of Leak Source 1 should be roughly 200 feet (60 meters) to the west. Figure A14 shows that the flight paths were correct for either position for the expected wind direction. Figure A15 confirms that the equipment was aimed in the correct position (about 32 feet [10 meters] from leak source) for the expected wind direction. The one gas detection seen in Figure A16 was a small, quick signal, which means only the low-concentration side of the gas cloud was detected. Figure A17 shows successful detections at the same leak source during runs on the next day in similar wind speed but with a different wind direction.

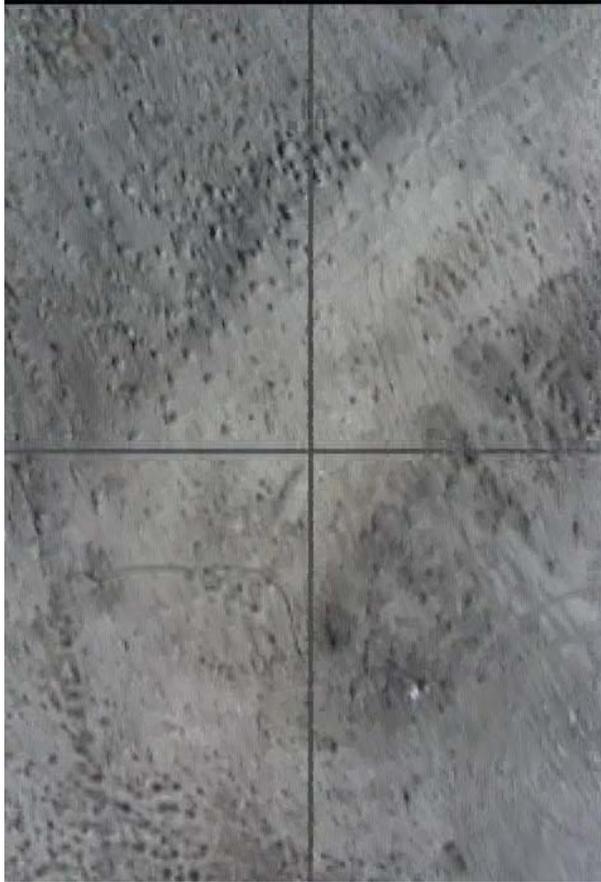
Figure A19. Pictures from the flight recording at Leak Source 6 during Run 3

The cause of the miss was an erratic wind direction. The different locations of leak detections shown in Figure A18 demonstrate how the wind direction varied during the runs. The picture in Figure A19 shows the flight path within 10 feet (3 meters) of the leak source on what was anticipated to be the downwind side. Offline analysis depicted in Figure A20 shows a quick signal which would correspond to a small, sparse gas cloud. Normally this data would prompt the operator to inspect the area again.
